Manhole Inspection Summary

Manhole # S31C__044MH

Insp Date: **5/26/09 3:52 PM**

Location Address: **501 PENNSYLVANIA AVE**

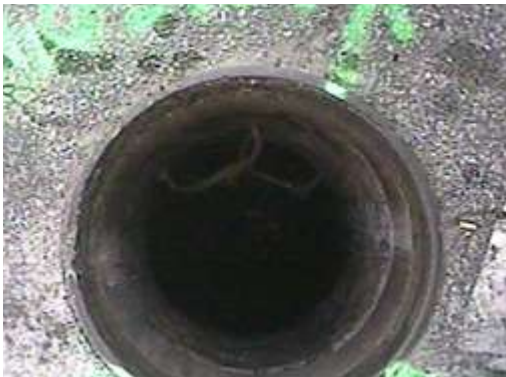
Defect 1

Count: **8** Missing: **0** ☒ **Corroded**

CORRODED STEPS

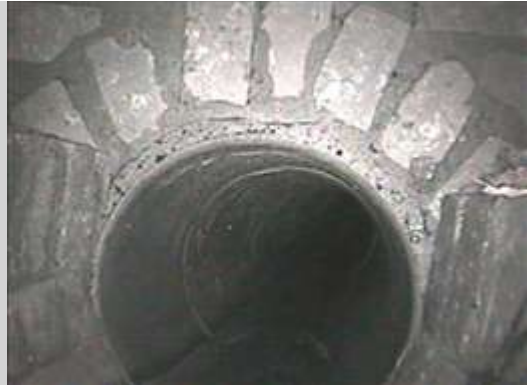
12 O'Clock Outflow

10 in. Circular Gravity Sewer
Pipe Out @ 12 O'Clock

Pipe Height: 6 (in.) Rod and Bar
Pipe Material: **Clay** ☐ Pipe Lined
Invert Depth: **13.54** (ft.) Flow Characteristics: **Slow**
Deposits: ☒ None ☐ Mud ☐ Sludge ☐ Debris ☐ Grease
Silt Depth: (in.) Deposits Extent:
Infiltration: **None** Pipe Seal Cond: **Sound**

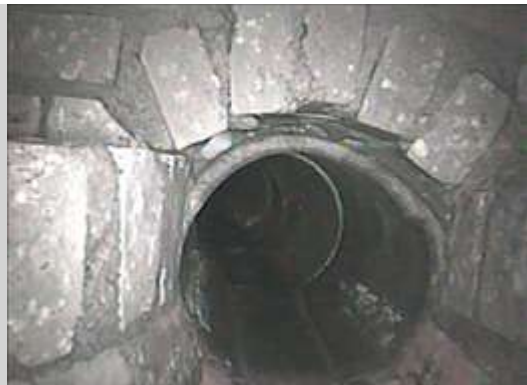
2 O'Clock Inflow

8 in. Circular Gravity Sewer
Pipe In @ 2 O'Clock

Pipe Height: (in.) Direct
Pipe Material: **Clay** ☐ Pipe Lined
Invert Depth: **13.37** (ft.) Flow Characteristics: **Slow**
Deposits: ☒ None ☐ Mud ☐ Sludge ☐ Debris ☐ Grease
Silt Depth: (in.) Deposits Extent:
Infiltration: **None** Pipe Seal Cond: **Cracked**

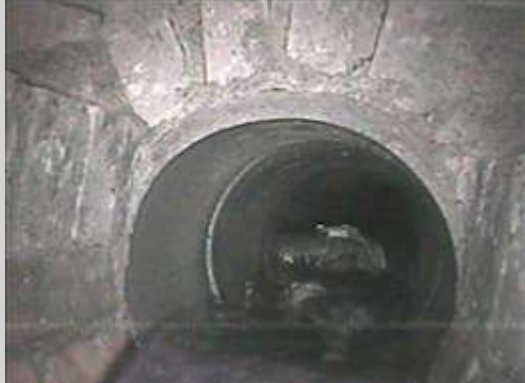
7 O'Clock Inflow

10 in. Circular Gravity Sewer
Pipe In @ 7 O'Clock

Infiltration: **None** Pipe Seal Cond: **Sound**
